Operation experience with a 1.8 K refrigeration unit during the 2024 LHC physics run at CERN

B Naydenov, L Delprat, M Pezzetti and B Bradu

European Organization for Nuclear Research (CERN), 1211 Geneva, Switzerland

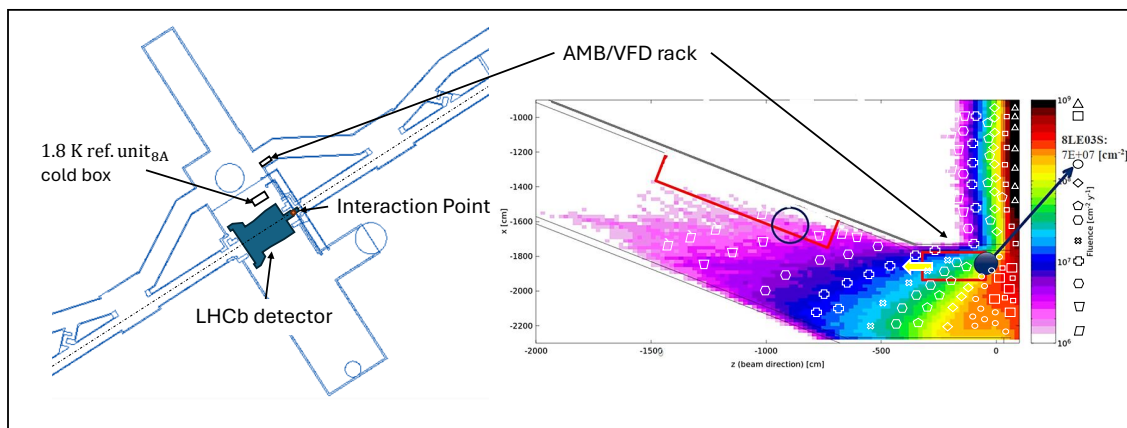
Focusing on the 2024 events, two $1.8K_{ref.unit_{8A}}$ stops occurred after a trip of the AMBC4 without an apparent reason. After the first trip, the unit was replaced. In both cases the trip occurred as particle collisions were being produced in LHCb, the detector located in the same cavern as $1.8K_{ref.unit_{8A}}$. The cumulated luminosity was 7.6 fm^{-1} and 10.1 fm^{-1} on the first and the second AMBC4 trip, respectively. FLUKA simulations on the location of the AMBC4, located nearby the cavern, indicate a fluence of $7 \times 10^7 \text{ HEH/cm}^2$ for 10 fm^{-1} as shown in Fig. 2 [7]. From previous studies [8] related to an initial displacement needed after the Long Shutdown 1, it is known that an AMBC failure is expected every $1 \times 10^8 \text{ HEH/cm}^2$. After an exhaustive check of all other potential sources for such trip, a Single Event Upset (SEU) was considered the most probable cause for the two trips. In both cases, there was no error message on the AMBC and, following a simple power recycle, they restarted working again, which is a typical behavior observed after a SEU. The mitigation measures consisted in displacing the cabinet 80 cm further away from the radiation source and adding additional iron shielding on the freed space.

Figure 2: High Energy Hadron (HEH) fluence on $1.8K_{ref.unit_{8A}}$ AMBC location for 10 fm^{-1} accumulated during Run 3. Displacement of 80 cm, indicated by an arrow, expected to reduce the fluence by a factor 2. [7]

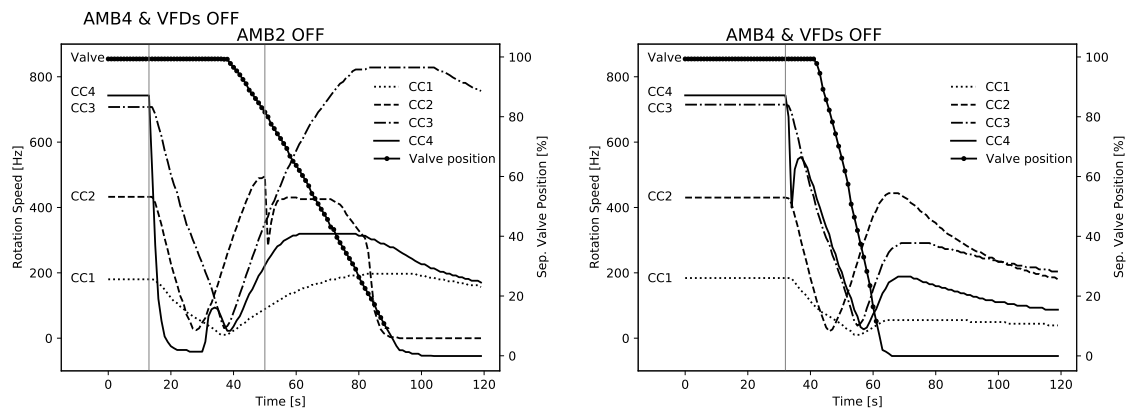
Focusing on 2024, the two AMBC4 trips directly led to a hard-landing of CC4. Moreover, on three separate occasions — following the first AMBC4 trip, the initial pressure sensor error, and the SVC-induced VFD trip — CC2 experienced reverse flow, leading to an overspeed condition. The reason for CC2 to reach such condition was an issue with the separation valve, which took longer than requested to close itself and isolate the impellers. Because of that, once the VFDs of the cold compressors stopped and the impellers went into free-spinning, the higher pressure at their outlet reversed the flow towards the low pressure side, i.e., the client side. Such situation led most of the compressor impellers to turn

(a) Slow EV (1'24") configuration at -1.5%/s. CC2 reached an overspeed condition (> 500 Hz), stopping its AMBC and hard-landing. (b) Faster EV (40") configuration at -4%/s. In this case, the overspeed condition of CC2 was narrowly avoided thanks to the faster closing of the separation valve.

Figure 4: Example of Cold Compressors (CCs) speed behaviour after two AMB4 trips with different separation valve closing speeds. In both cases, the release of air, and hence the closing speed of the valve, was controlled by the safety electric valve (EV).

backwards as the separation valve was closing (Fig. 4), and CC2 to reach an overspeed condition due to which it hard-landed (Fig. 4a). After three such events occurred on CC2, the calibration check was not passed anymore and the unit had to be replaced with a spare one and sent for repair. Due to the criticality of $1.8K_{ref.unit_{SA}}$ and the importance of a prompt recovery, such intervention was done for the first time by warming-up only the train of compressors and keeping the rest of the unit cold.

An AMB failure during normal operation inevitably leads to a hard-landing. However, the reverse-flow induced hard-landing following any other failure cause can be avoided. A non-return valve at the outlet of a compressor is a standard approach to resolve the reverse flow phenomena following a trip. However, it adds additional pressure drop to the system, which has direct negative consequences on the total pumping capacity of the unit [10]. Another solution is to ensure that the separation valve closes faster than the speed decrease of the impellers in freewheel mode. If this is not possible, the valve should close faster than the shortest time it takes for any impeller to reach an overspeed condition.

Depicted in Fig. 5b, the separation valve is controlled by a pneumatic actuator. For safety considerations, it is a normally closed valve. The normal control chain consists in routing pressurized air to the pneumatic actuator through the positioner. The latter receives the set point from a PLC, measures the actual position on the actuator, and sends or releases air from it in order to adjust the position. An electric valve (EV) is installed in series, taking over the closing of the valve in case of an emergency. Whenever an AMB is lost, it releases the air from the pneumatic actuator directly through "Exhaust air 2" indicated in Fig. 5b. Over the year, it became clear that the existing exhaust restriction on the EV was improperly sized, preventing the valve from closing quickly enough. This can be seen when comparing Fig. 4a and Fig. 4b, with and without the added restriction. CC2 enters in an overspeed condition with the restriction, and misses it closely without. During the YETS, the existing EV was replaced with a larger orifice and a larger exhaust restriction one. In addition, the positioner was adjusted such that it does not fill the actuator with the maximum available compressed air pressure, but rather with just enough pressure to keep the spring compressed and the valve open, reducing the amount of air to be released. The combined measures allowed reducing the closing time of the valve from 45 s to 10 s. Such speed proved to be enough to prevent a future overspeed induced hard-landing.
