Operation experience with a 1.8 K refrigeration unit during the 2024 LHC physics run at CERN

B Naydenov, L Delprat, M Pezzetti and B Bradu

European Organization for Nuclear Research (CERN), 1211 Geneva, Switzerland

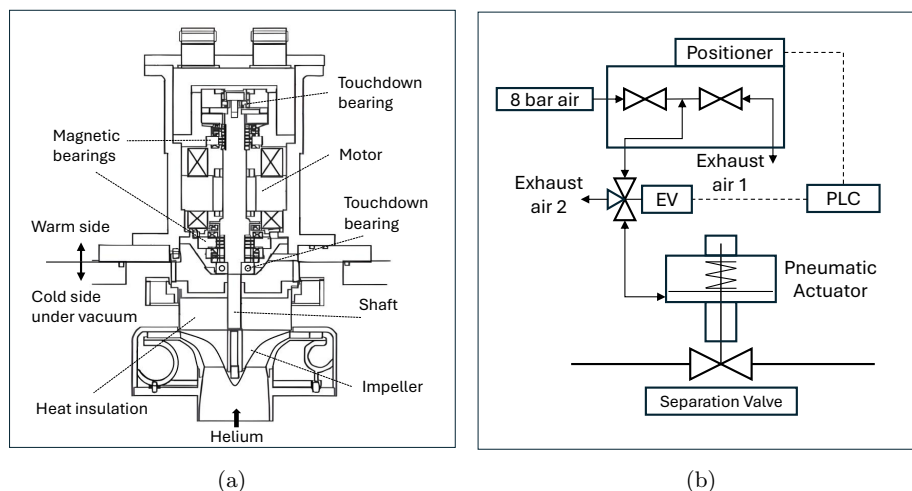
- A controlled stop. The VFDs decrease the rotation speed to their idle speed. From there, they are slowed down further, and only when they are almost not spinning, the AMBC stops the levitation. At that point, the shaft lands smoothly on a ceramic touch down ball bearing depicted in Fig.5a.

To reduce the added pressure drop, a DN250 butterfly valve is used as a separation valve shown in Fig. 1b. Its safety interlocks strategy defines different closing methods depending on the type of failure. Following the events of 2024, this strategy was fully revised with the goal of reducing a hard-landing probability, and hence, the repair time.

Figure 5: (a) Typical CC cartridge cross-section indicating the magnetic and the touchdown ceramic bearings. (b) Separation valve interlock strategy, including a valve positioner, its actuator, an electric valve (EV) and a Programmable Logic Controller (PLC). The compressed air is routed to the actuator through the positioner and the EV. Different conditions can trigger the release of air to close the valve.

Depicted in Fig. 5b, the separation valve is controlled by a pneumatic actuator. For safety considerations, it is a normally closed valve. The normal control chain consists in routing pressurized air to the pneumatic actuator through the positioner. The latter receives the set point from a PLC, measures the actual position on the actuator, and sends or releases air from it in order to adjust the position. An electric valve (EV) is installed in series, taking over the closing of the valve in case of an emergency. Whenever an AMB is lost, it releases the air from the pneumatic actuator directly through "Exhaust air 2" indicated in Fig. 5b. Over the year, it became clear that the existing exhaust restriction on the EV was improperly sized, preventing the valve from closing quickly enough. This can be seen when comparing Fig. 4a and Fig. 4b, with and without the added restriction. CC2 enters in an overspeed condition with the restriction, and misses it closely without. During the YETS, the existing EV was replaced with a larger orifice and a larger exhaust restriction one. In addition, the positioner was adjusted such that it does not fill the actuator with the maximum available compressed air pressure, but rather with just enough pressure to keep the spring compressed and the valve open, reducing the amount of air to be released. The combined measures allowed reducing the closing time of the valve from 45 s to 10 s. Such speed proved to be enough to prevent a future overspeed induced hard-landing.
